25 years of pollution abatement  
and environmental improvement in the

# GUDENAA

- a Danish lake-river-estuary system

GUDENAA COMMITTEE - REPORT NO. 21  
MAY 1999

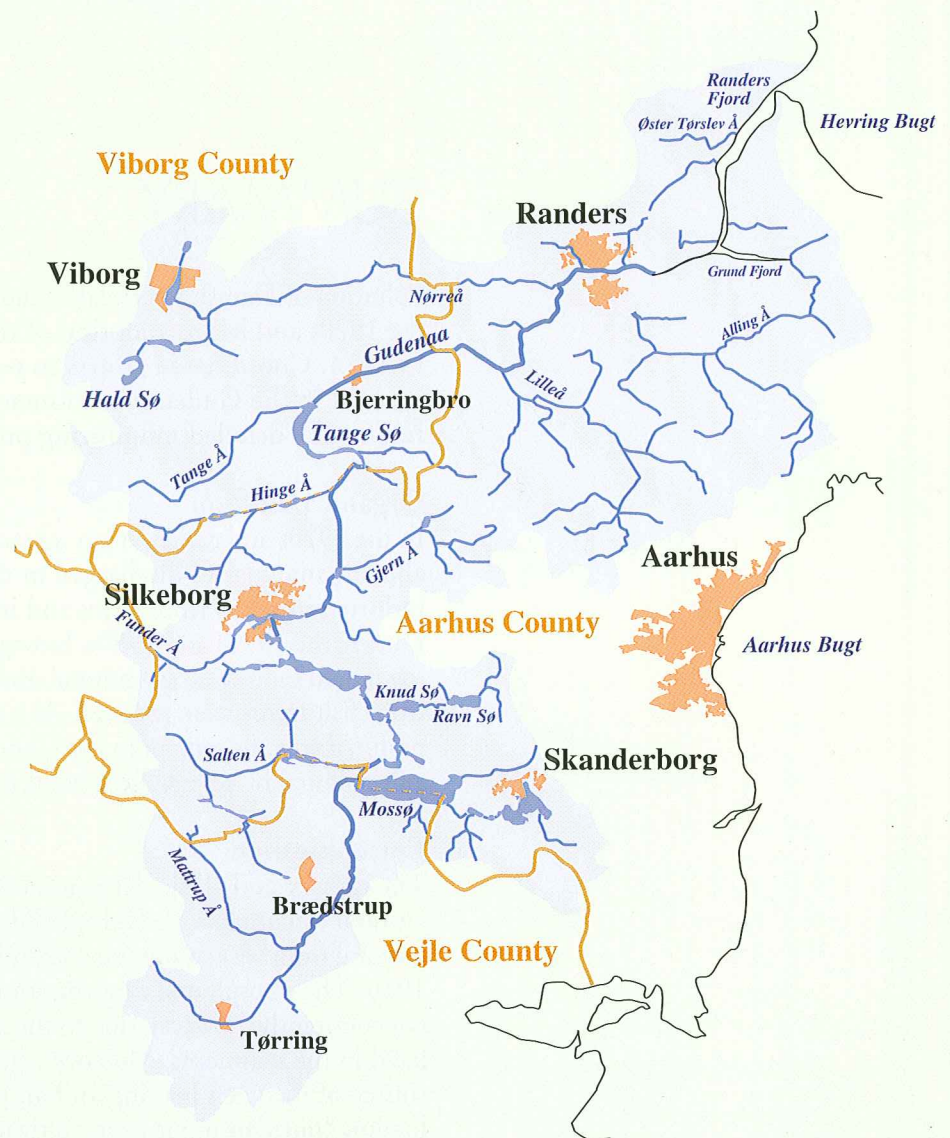
Fig. 1. Gudena river system indicating the catchment area (blue) and the county borders (brown).

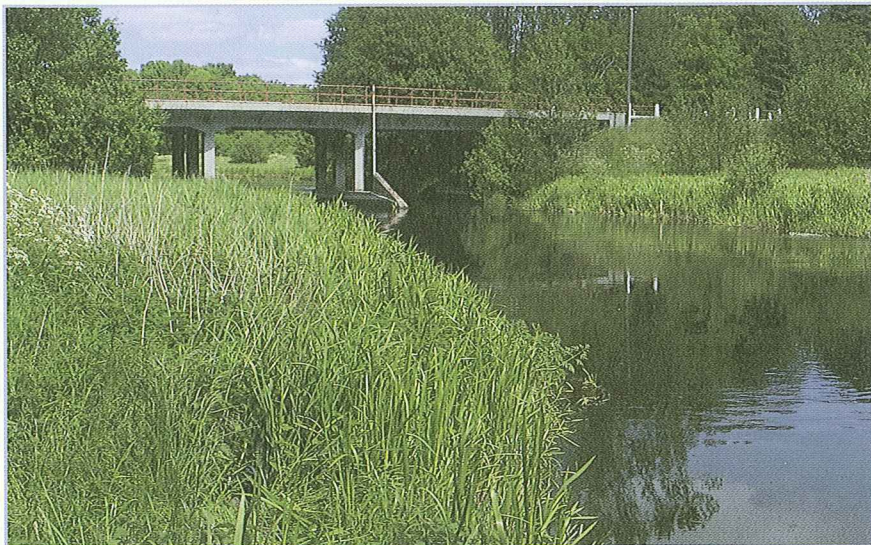
*The water discharge monitoring station at Tvilum Bridge north of Silkeborg was established in 1917.*

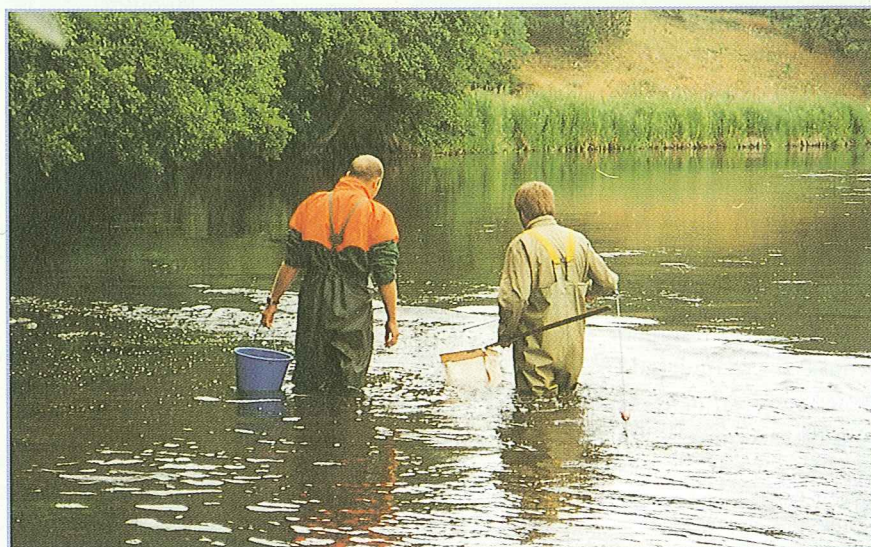
*Fish populations and spawning results are monitored by electrofishing.*

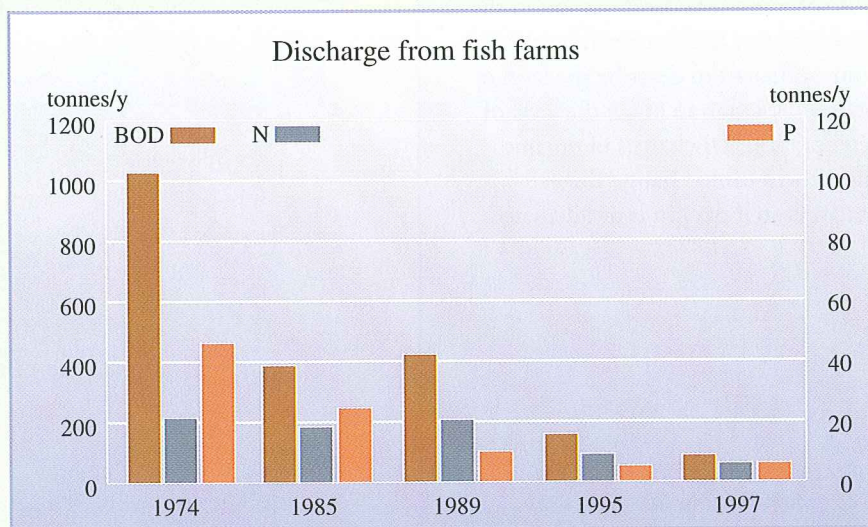
Fig. 5. Annual discharge of organic matter (BOD), nitrogen and phosphorus from all fish farms in the Gudena river system 1974-97.

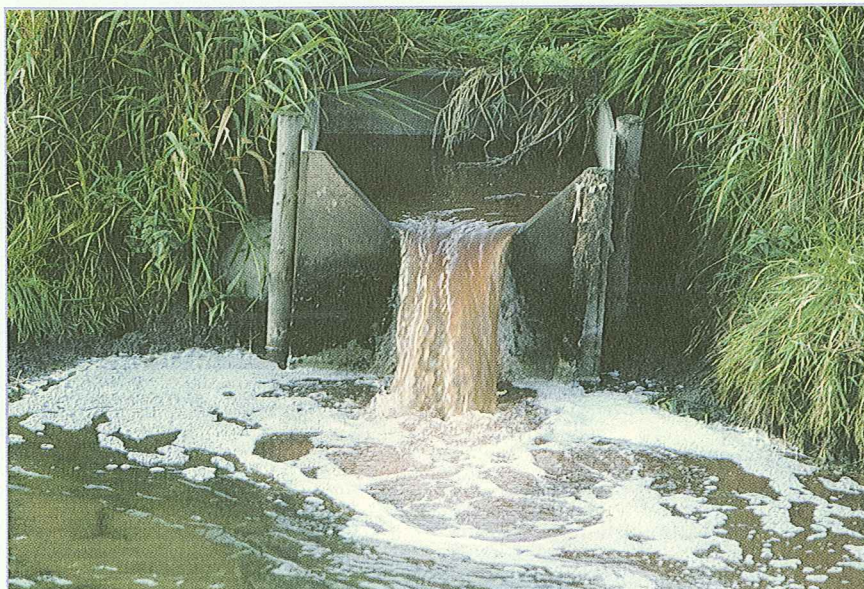
Wastewater discharge from a slaughterhouse to Lilleaa 1976. Photo: Bent Lauge Madsen

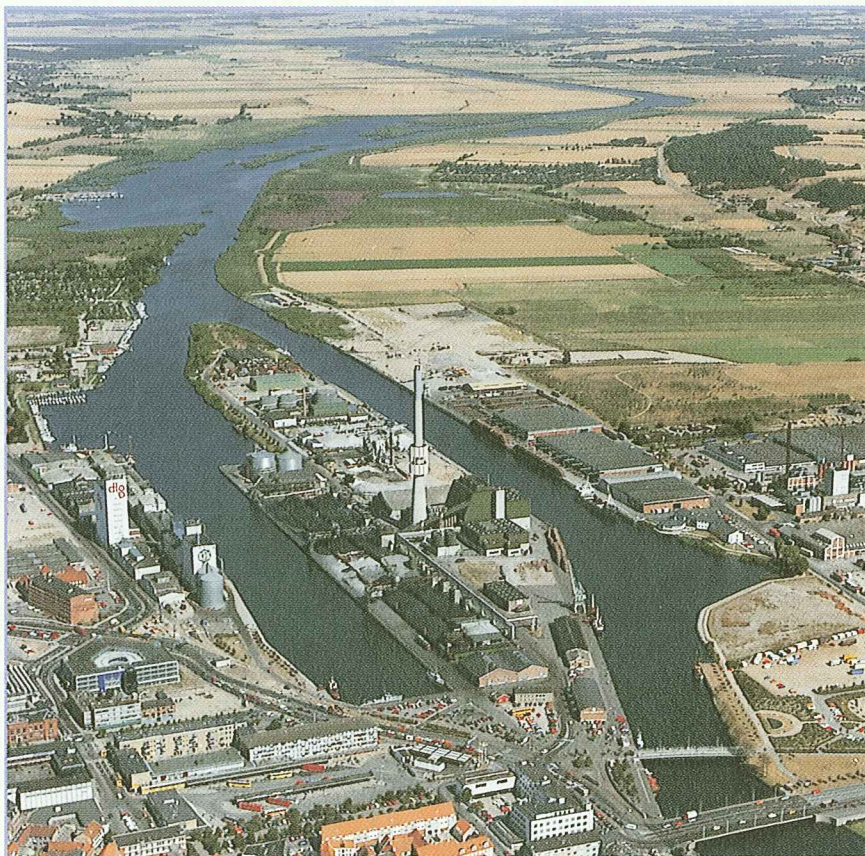
Before the establishment of biological wastewater treatment in the town of Randers the inner part of the estuary was polluted by organic matter.

In the estuary, Randers Fjord, direct discharge of organic matter in wastewater was high enough to cause sludge deposition and oxygen depletion in the inner part of the estuary, thereby affecting the benthic invertebrates. Since the establishment of effective removal of organic matter from wastewater, organic matter loading of the estuary has mainly been attributable to algal production in the upstream lakes.

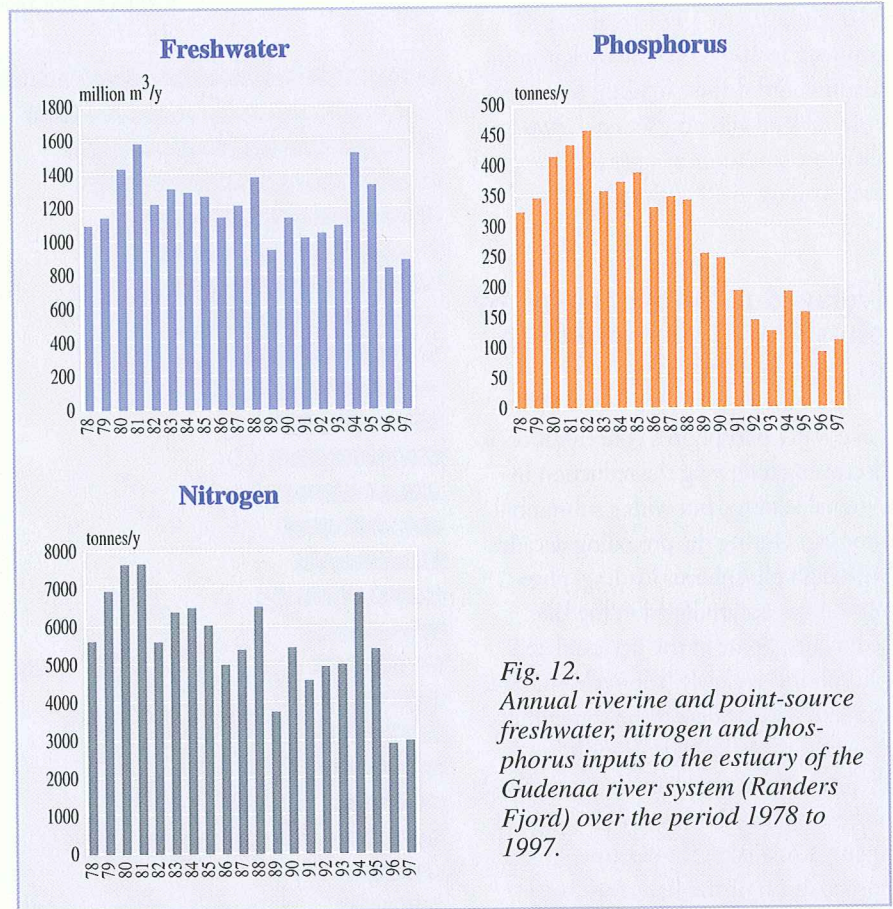
Fig. 12. Annual riverine and point-source freshwater, nitrogen and phosphorus inputs to the estuary of the Gudenaa river system (Randers Fjord) over the period 1978 to 1997.

Wastewater discharge and agricultural production have enhanced nitrogen and phosphorus transport approximately 10-fold as compared with natural levels. Most of this increase has occurred during the 20th century. Since the 1980s, phosphorus loading has declined markedly due to wastewater treatment while the reduction in nitrogen loading has been less obvious (Fig. 12).

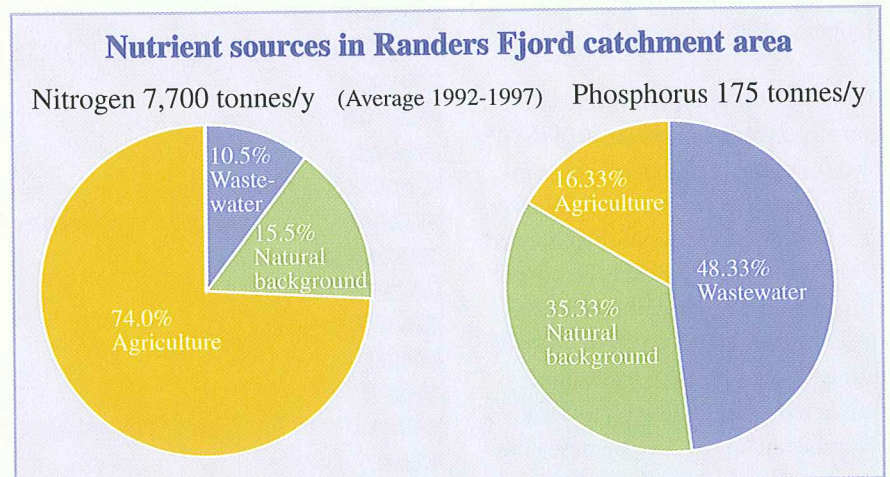
Fig. 13. Nitrogen and phosphorus input to the estuary of the Gudenaa river system (Randers Fjord) apportioned by source (annual average values for the period 1992-1997).

The main nutrient sources in the 1990s are agriculture in the case of nitrogen and wastewater in the case of phosphorus (Fig. 13). Total nutrient loading within the catchment far exceeds the background levels.

have been reduced even more, cf. Fig. 13. According to the 1987 Action Plan on the Aquatic Environment, nitrogen loading from agricultural sources is to be reduced by 50%.

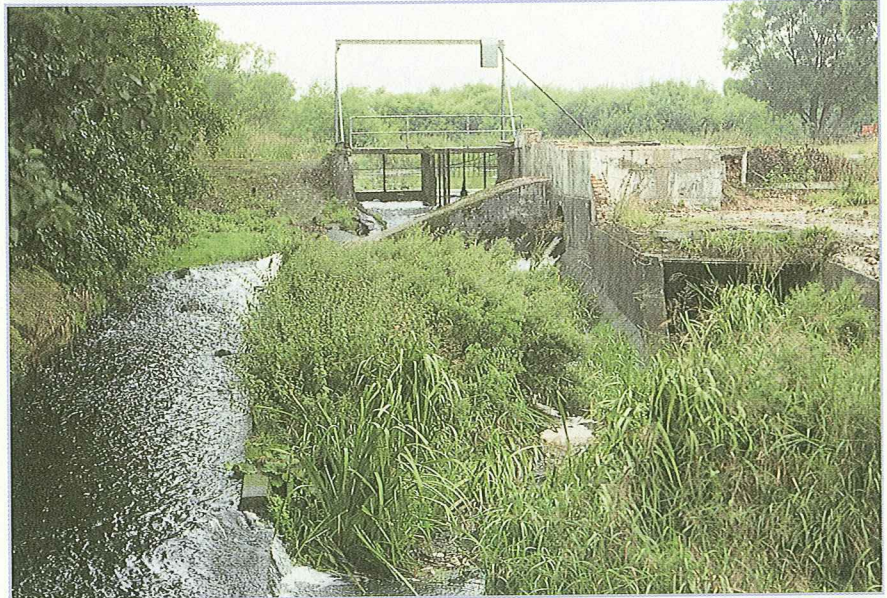
*Dams at old mills have prevented fish migration. According to the Gudenaa Committee recommendation, most of these fish passage obstacles have been removed.*

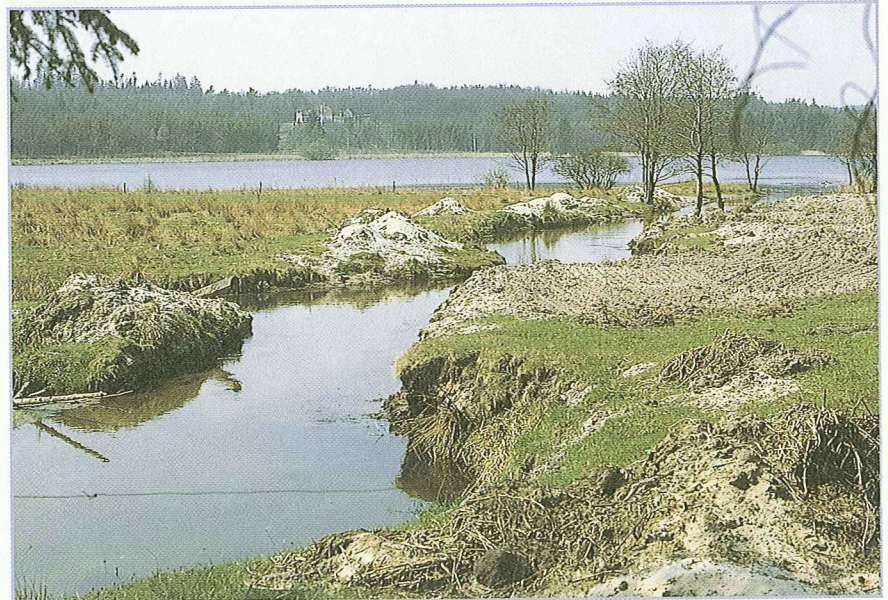
*Until the 1980s the stream ecosystems were often destroyed by stream maintenance undertaken to improve the drainage of water from agricultural fields in the stream valleys.*

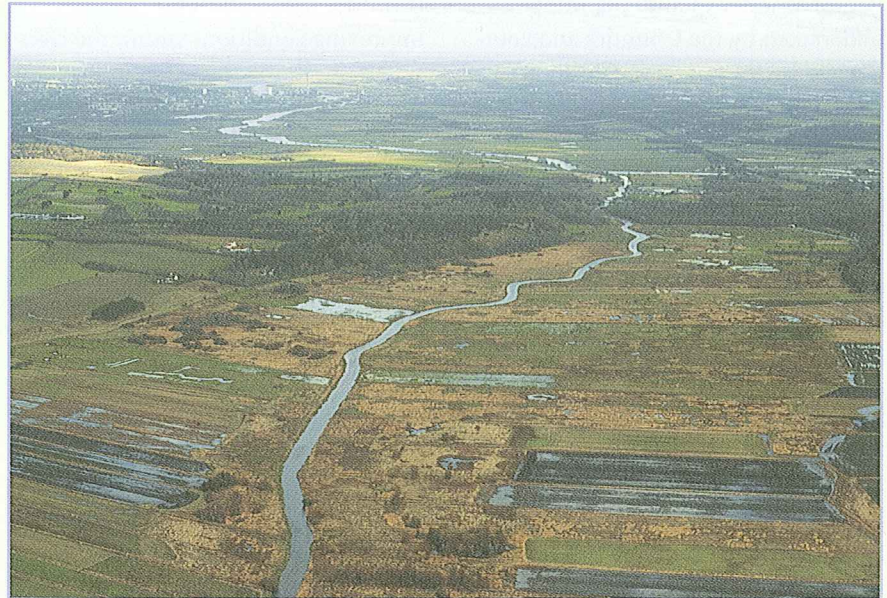
Most streams have been channelized to improve the agricultural use of the stream valleys. Restoration of streams and wetlands will reduce the nutrient transport through the streams and improve the ecological qualities of the streams and valleys. Photo: E. W. Olsson
